A LABORATORY STUDY OF THE ROLE OF GEOTECHNICAL  
FABRIC AS A SEPARATION MEDIUM IN A  
SOIL FABRIC SYSTEM

Submitted to the Faculty of the Graduate College  
of the Oklahoma State University  
in partial fulfillment of the requirements  
for the Degree of  
MASTER OF SCIENCE  
July, 1981

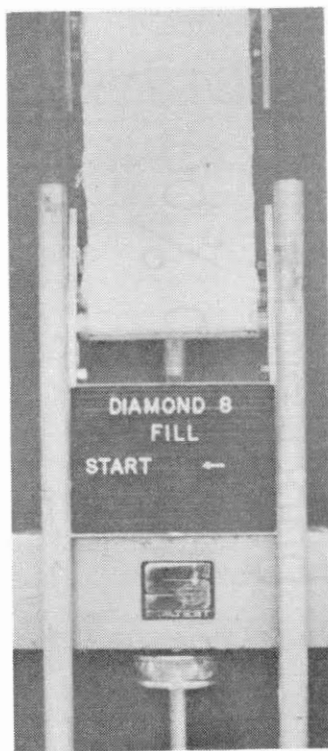
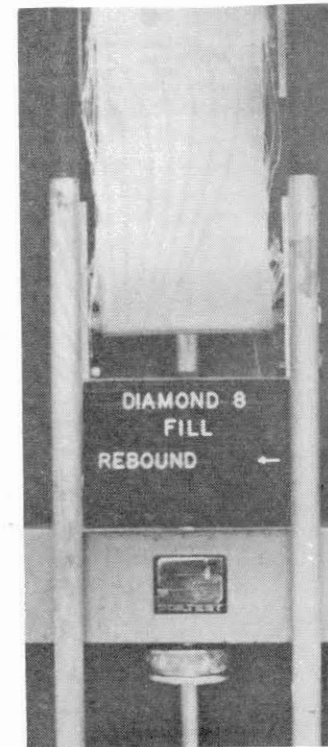
Figure 25. Photographs of Diamond 8-Fill Direction in Tension Testing at (Left to Right) Start, 10 Percent Strain, Failure, and After "Elastic" Rebound
